FINAL SUMMARY REPORT
FOR
CRUM'S BROOK RESTORATION
AREA C INTERIM REMEDIAL MEASURE
IN
TOWN OF ISLIP, NEW YORK

NOVEMBER 2002

Regarding the Summary Report for Crum's Brook Restoration, Area C Interim Remedial Measure, dated November 2002 for the former Bayshore Manufactured Gas Plant site located in Islip, New York:

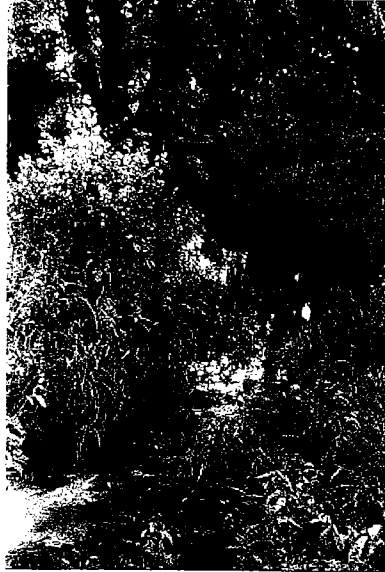
Before remedial activities took place, much of the channel was overgrown and poorly developed.

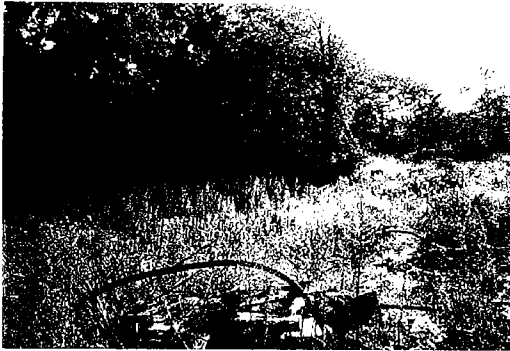
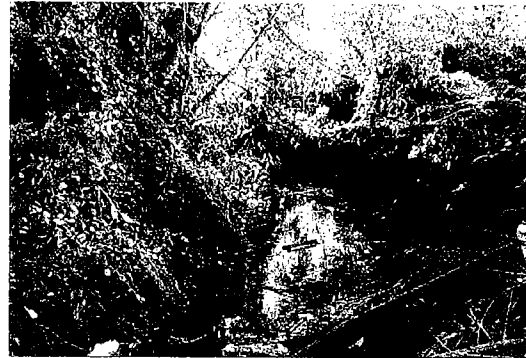
Debris was found in and near the brook.

Preparations for the performance of the specified work included clearing and grubbing of the brook, banks, and uplands to support restoration activities; chipping / shredding of vegetation (trees larger than six (6) inches were left in place); removal of debris from within the brook and uplands working area; and the decontamination of debris.

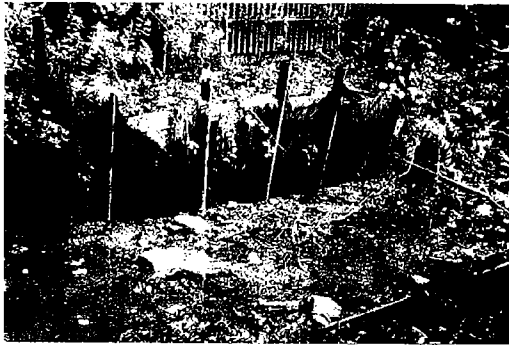
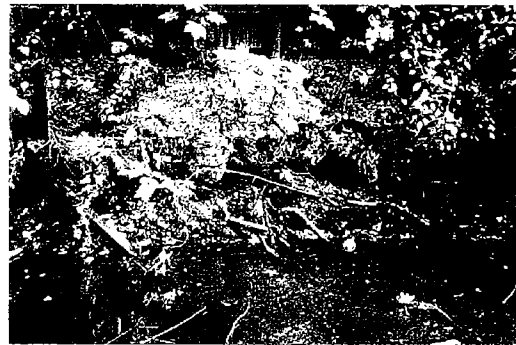
Makeshift retaining walls were found in neighborhood yards.

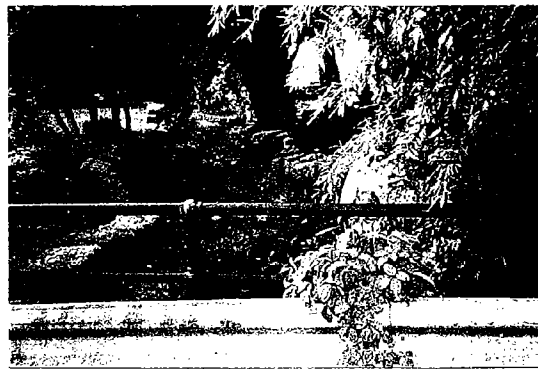
Erosion control measures were put in place after clearing and grubbing in the channel corridor.

Mobilization to the site required the setting up of temporary facilities such as decontamination facilities and a HDPE lined mixing pad (for sediment drying / dewatering activities) adjacent to the brook on the South Wind Village Development Site. Installation of the surface water diversion system, and sediment and erosion control measures also took place during this phase.

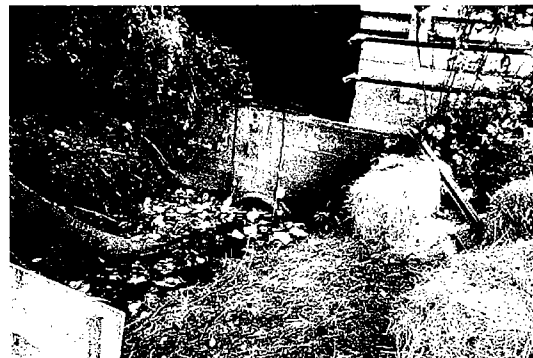
Check dams were placed in sections of the brook, and water was routed downstream of restoration activities through the use of hoses, pumps, and piping.

Dewatering was completed successfully in sections by placing check dams at one hundred to two hundred foot intervals and rerouting the water downstream through the use of hoses, pumps, and an above ground piping system.

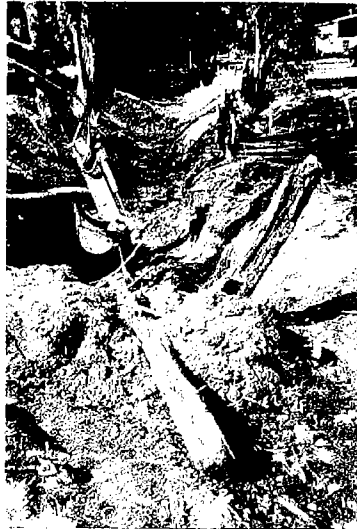
After a section was dewatered, a minimum of twelve (12) inches of sediment from the brook channel was removed, placed in a temporary drying pad, and properly disposed of as non-hazardous material.

This phase was also conducted in sections and included the removal of a minimum of one (1) foot vertically of sediment using an excavator from the entire length of the brook between Union Boulevard and Mechanicville Road (approximately 1400 feet long) and 2.5 feet to both sides of the existing stream centerline (or bank, if closer). The sediment was transported on-site from the excavation area to the sediment mixing pad. Pre-excavation dewatering was so successful that a mixing agent was not necessary for the sediment to be disposed of off-site.

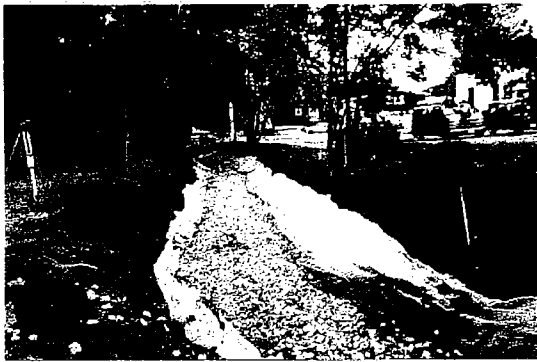
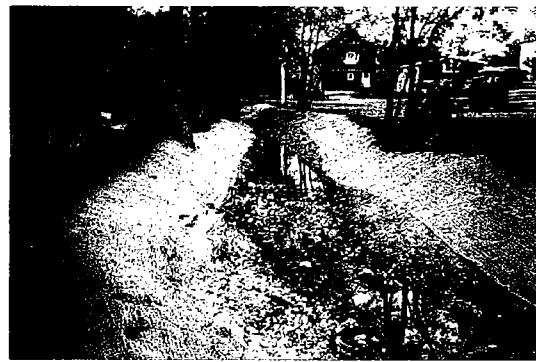
After the new channel was formed, an erosion control mat was placed over filter fabric. A minimum of six (6) inches of 3" diameter stone was placed on top of the mat where the brook now flows.

The streambed was composed of a non-woven filter fabric overlain by a woven filter fabric, and six inches of 3" D50 stone. Stream side slopes maintained a uniform 2:1 ratio and were overlain with a biodegradable stabilization mat keyed into the stone stream bed and the top of the slope and underlain by a minimum of six (6) inches of top soil. Grading along the eastern extent provided a smooth transition with as minimal as practical disturbance to the existing property.

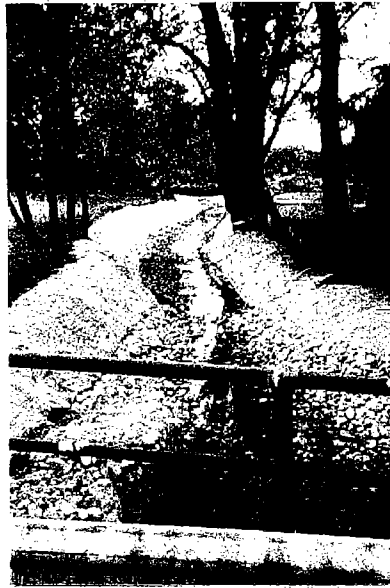
Minimal trees were removed when restoring the channel, as shown here with the stream being slightly rerouted to preserve the tree's roots.

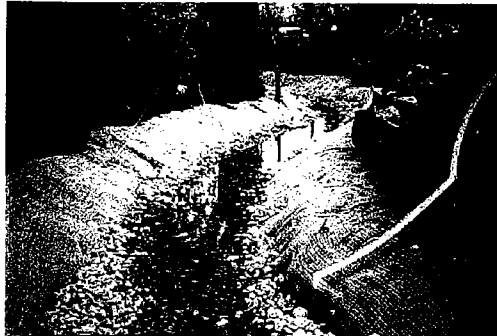
Once the Crum's Brook restoration was completed, erosion control measures were left in place on the development side of the brook. The fence and hay bales will be removed by others when construction activities for the South Wind Village Development cease.

This final phase consisted of the removal of all temporary construction facilities, removal of sediment and erosion control measures (on the east side only), and the restoration of the work area to its original condition. Silt fencing and hay bales were left in place on the western bank because the transition to final grade adjacent to the South Wind Village property would not be achieved until construction of the development was completed. Once the construction phase of the South Wind Village development was completed, the stream enhancement planting plan was implemented. During the fourth quarter of 2001, shrubs were planted along the brook in accordance with **Appendix G**. The northeast wildflower seed mix will be applied during the upcoming planting season.
